BIRD STRIKE CAPABILITIES OF TRANSPARENT AIRCRAFT
WINDSHIELD MATERIALS. PART II. SUPPLEMENTAL
EVALUATION OF PARAMETERS AFFECTING MATERIALS RESPONSE

Goodyear Aerospace Corporation

AFML-TR-74-234
Part II

Part II. Supplemental Evaluation of Parameters Affecting Materials Response

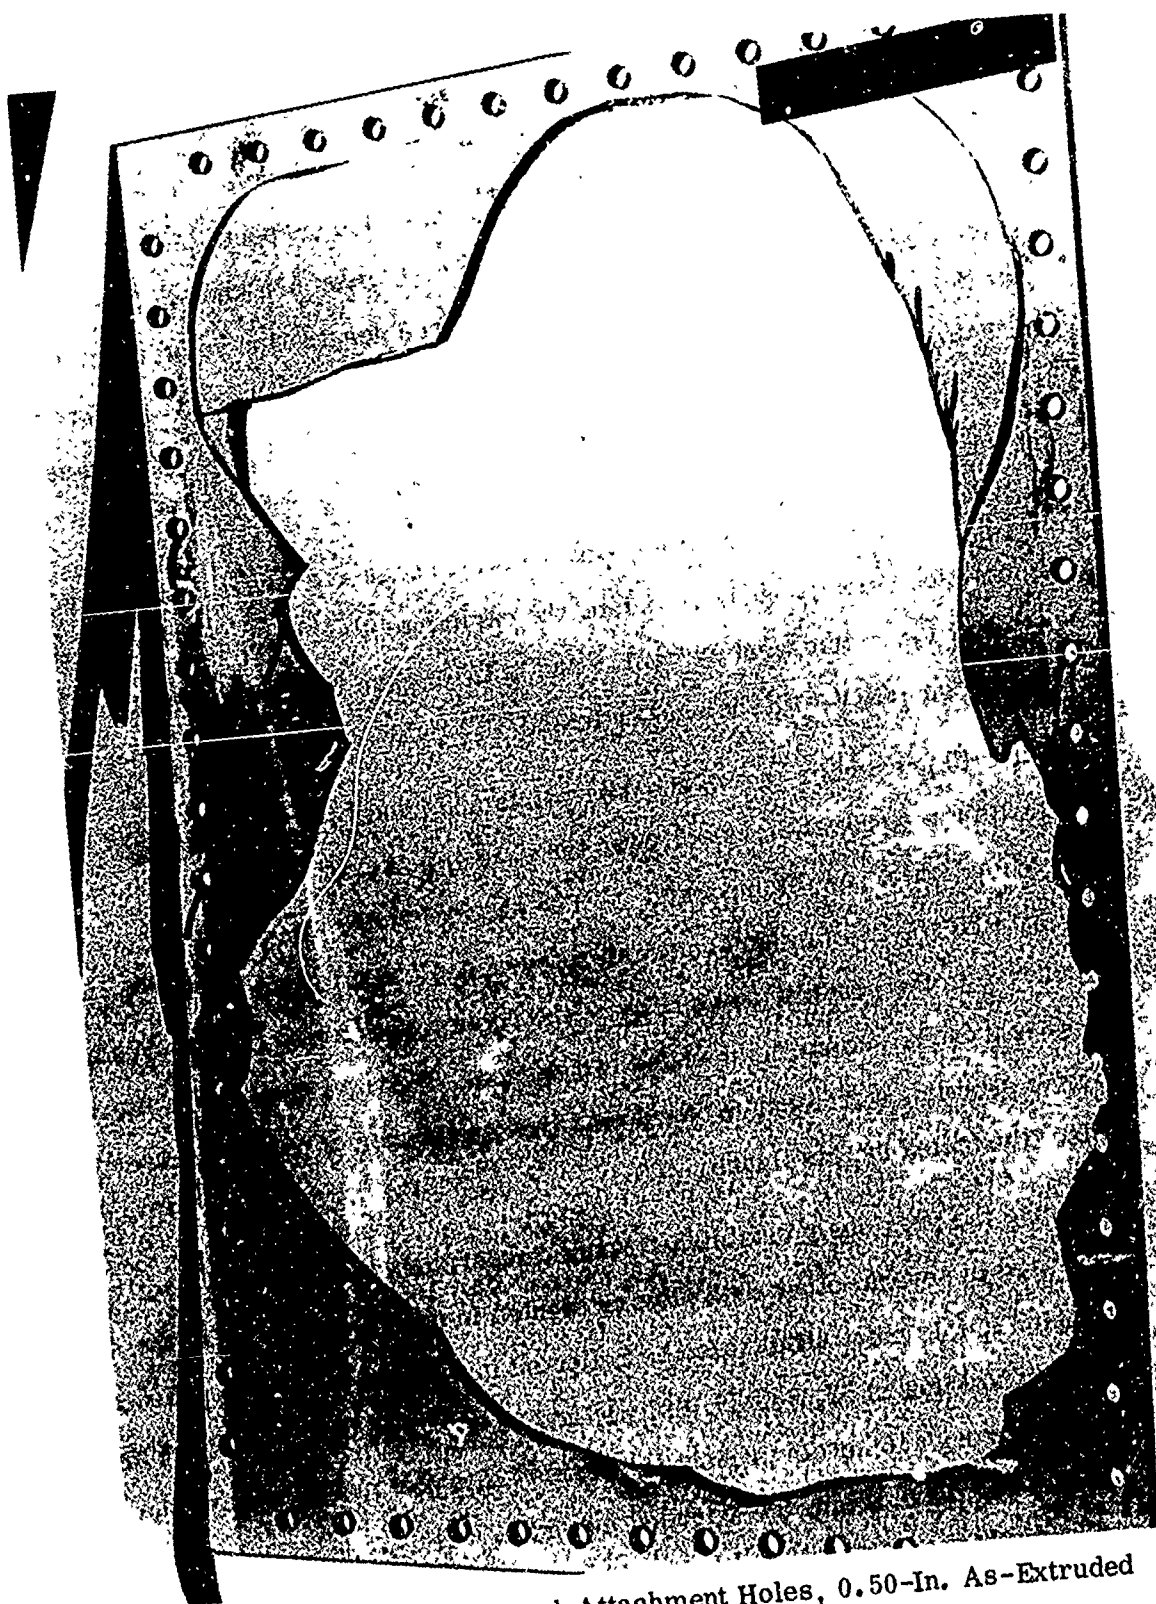
at various panel temperatures (see Table 10). Again, one room temperature panel (No. 4.1.16) failed at about the same velocity as in the prior test series. However, failure occurred through some of the attachment holes along one side (see Figure 9), so this test was also suspect. A second panel tested (4.1.17) withstood multiple impacts up to over 375 knots. It is felt that this panel more nearly represents the true penetration velocity for the 0.50-in. as-extruded polycarbonate at room temperature based on comparison with the results obtained for similar optically treated panels tested at the same test parameters.

Figure 9. Failure Through Attachment Holes, 0.50-In. As-Extruded Polycarbonate at 45-Deg Impact Angle

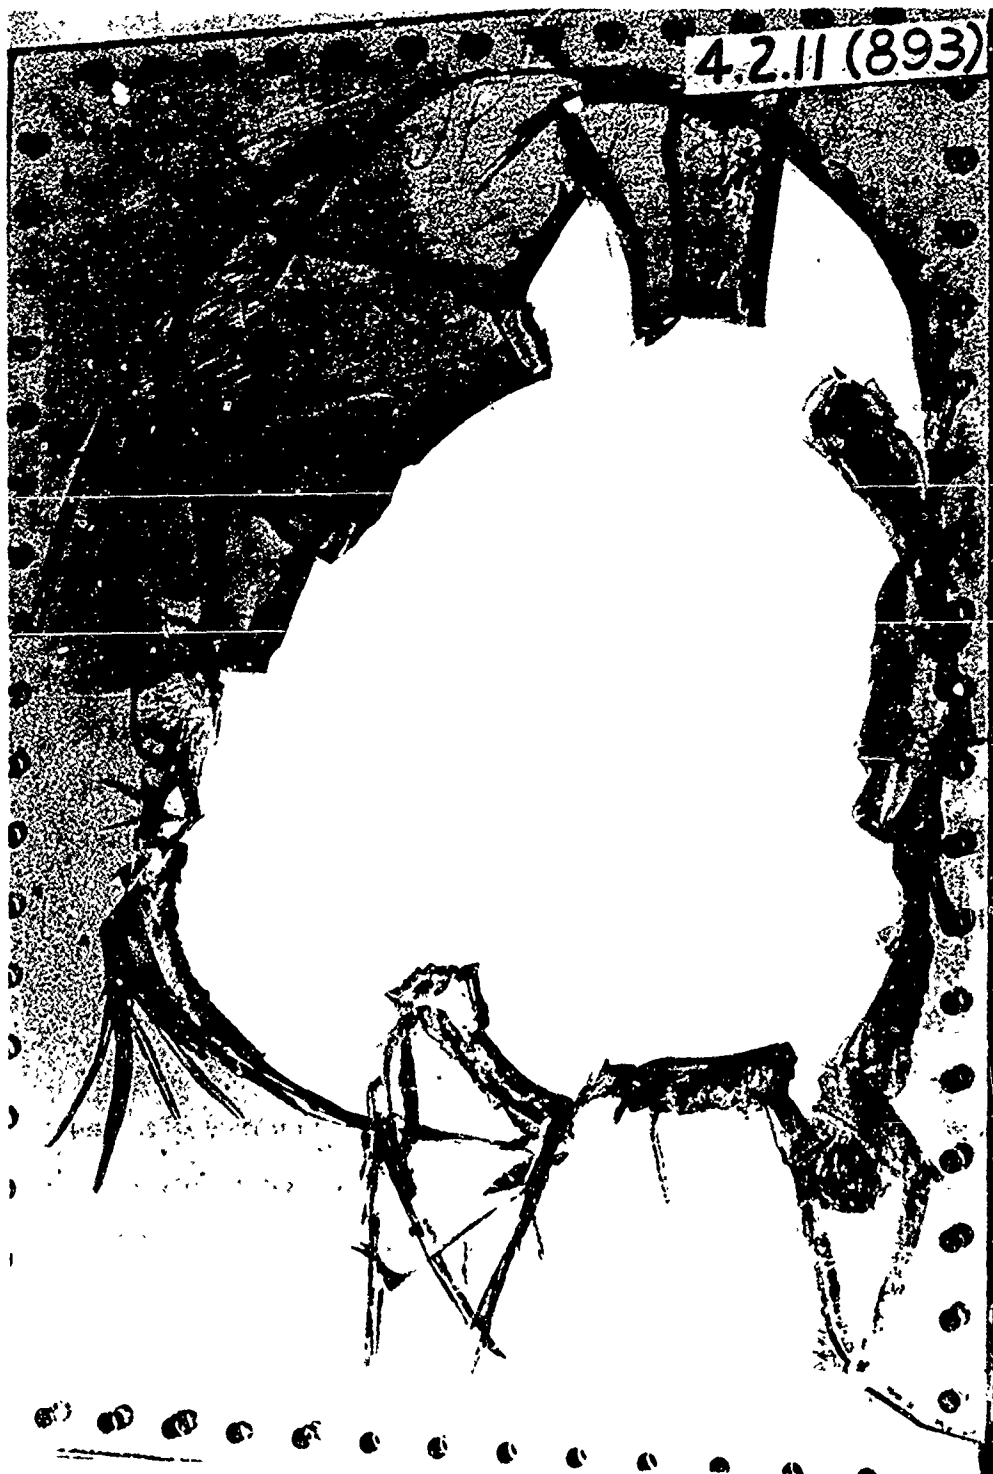
Figure 20. Failure Mode Center Edge Impact, 1.0-In. Fusion-Bonded Polycarbonate at 45-Deg Impact Angle

velocities about 8 percent higher than were achieved for impacts at the geometric center of 0.50-in. monolithic polycarbonate panels. This slight increase may be because as the bird impacts and spreads out, a portion of the impact loads is transferred directly to the support frame. Also, some bird mass is soon deflected off the nearer edge of the panel and the panel is no longer required to apply work to that portion of the bird mass. The impacts in the rear corner of the monolithic panel were 16 percent lower than the center impacts at the 45-deg bird impact angle. Severe panel deflections and pocketing of the bird in the rear corner accounts for the lower penetration velocities for this condition. At the 30-deg bird impact angle, the penetration velocity for the rear corner impact is about 22 percent less than that for an impact in the panel center. Again, this is due to the severe pocketing with the failure mode consisting of local failure of the panel along the inside edge of the support frame (see Figure 21). Figure 22 presents a plot of the test results along with the curve for the center impacts on the 0.50-in. monolithic material. Figure 23 summarizes the effects of impact location for the 0.50-in. monolithic polycarbonate material.

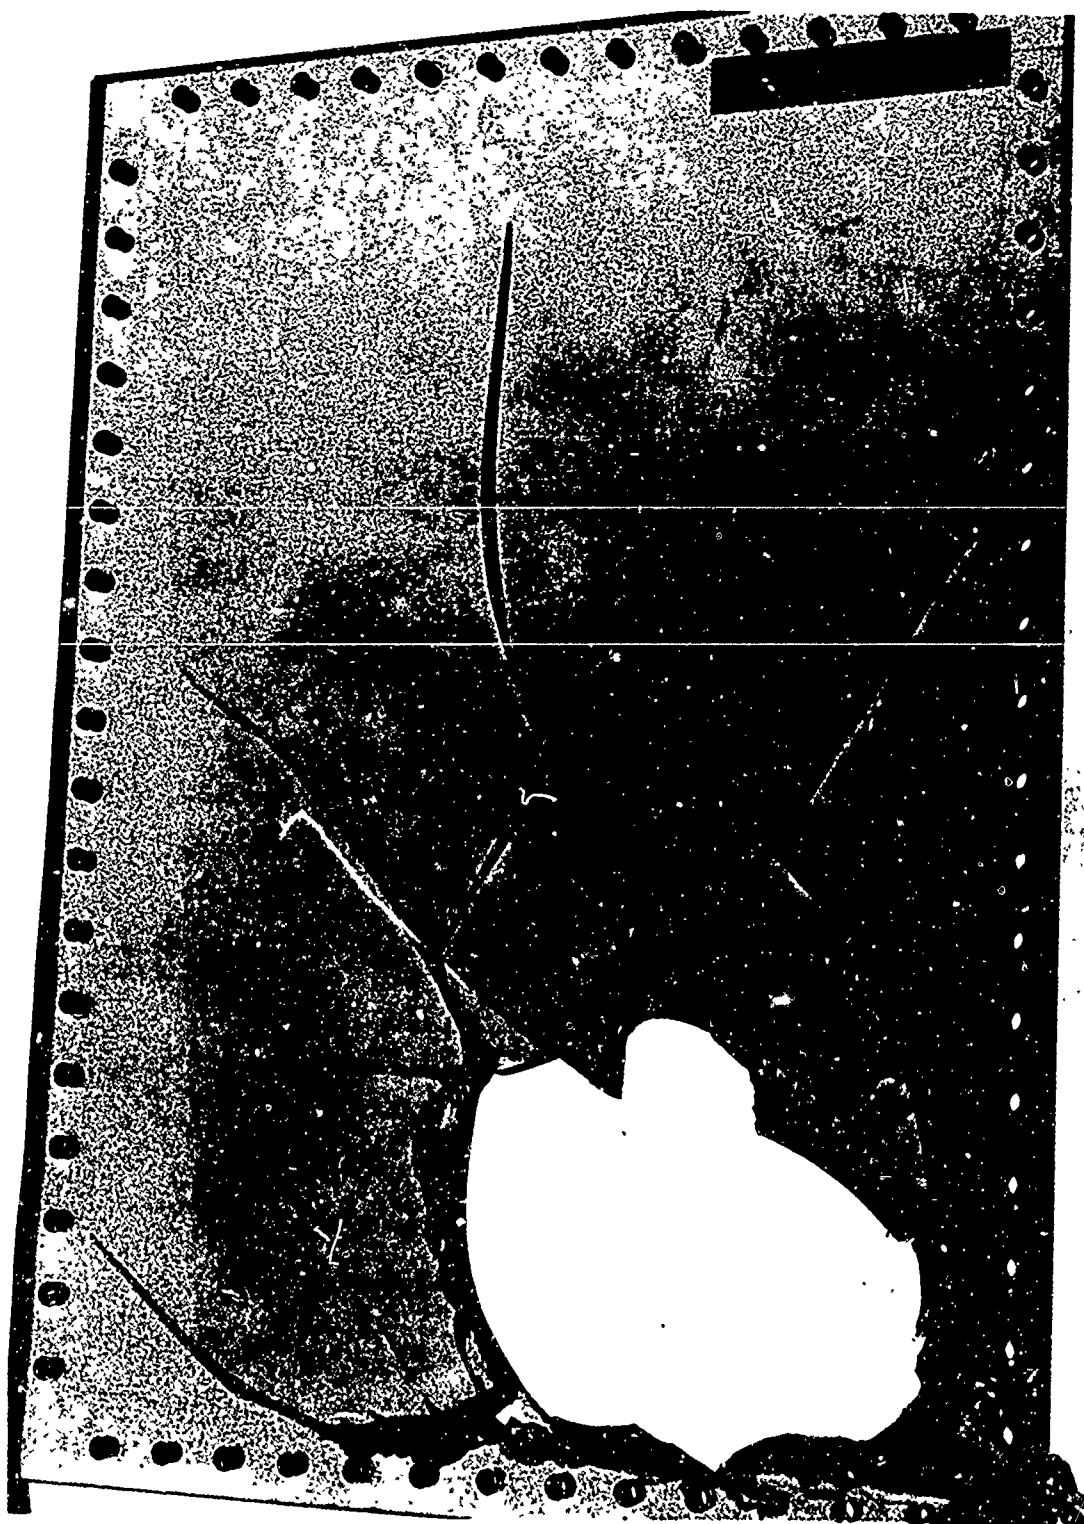
Two 1.0-in.-thick panels were also tested using aft corner impacts. Both were tested at the 45-deg bird impact angle. As was the case for the edge impacts, the 1.0-in. panels are also less forgiving for corner impacts. The performance of these two tests when compared with similar center impact tests shows approximately a 40-percent reduction in the penetration velocity for the corner impacts. This was the highest comparative reduction for all of the tests in this series. The typical failure mode for both these tests was local punch-through at the point of impact (see Figure 24).

Figure 24. Failure Mode Aft Corner Impact, 1.0-In. Fusion-Bonded Polycarbonate at 45-Deg Impact Angle

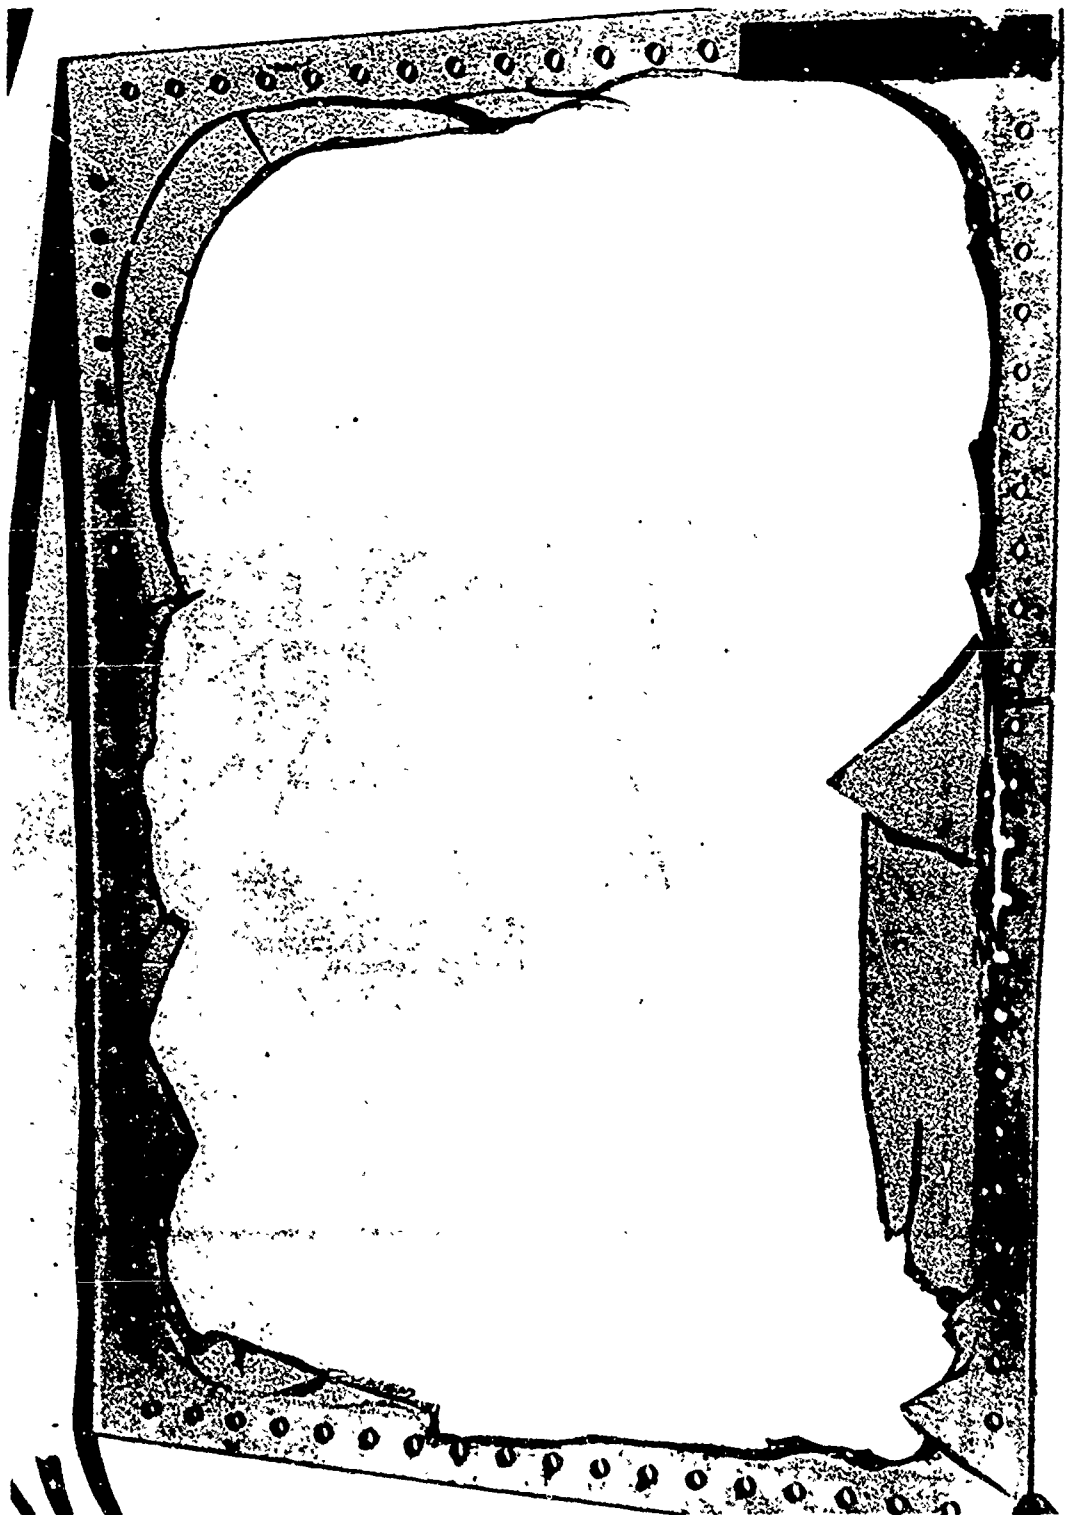
Figure 26. Failure Mode 0.312-In. -Diameter Fasteners at 1.5-In. Spacing,
0.50-In. As-Extruded Polycarbonate at 45-Deg Impact Angle

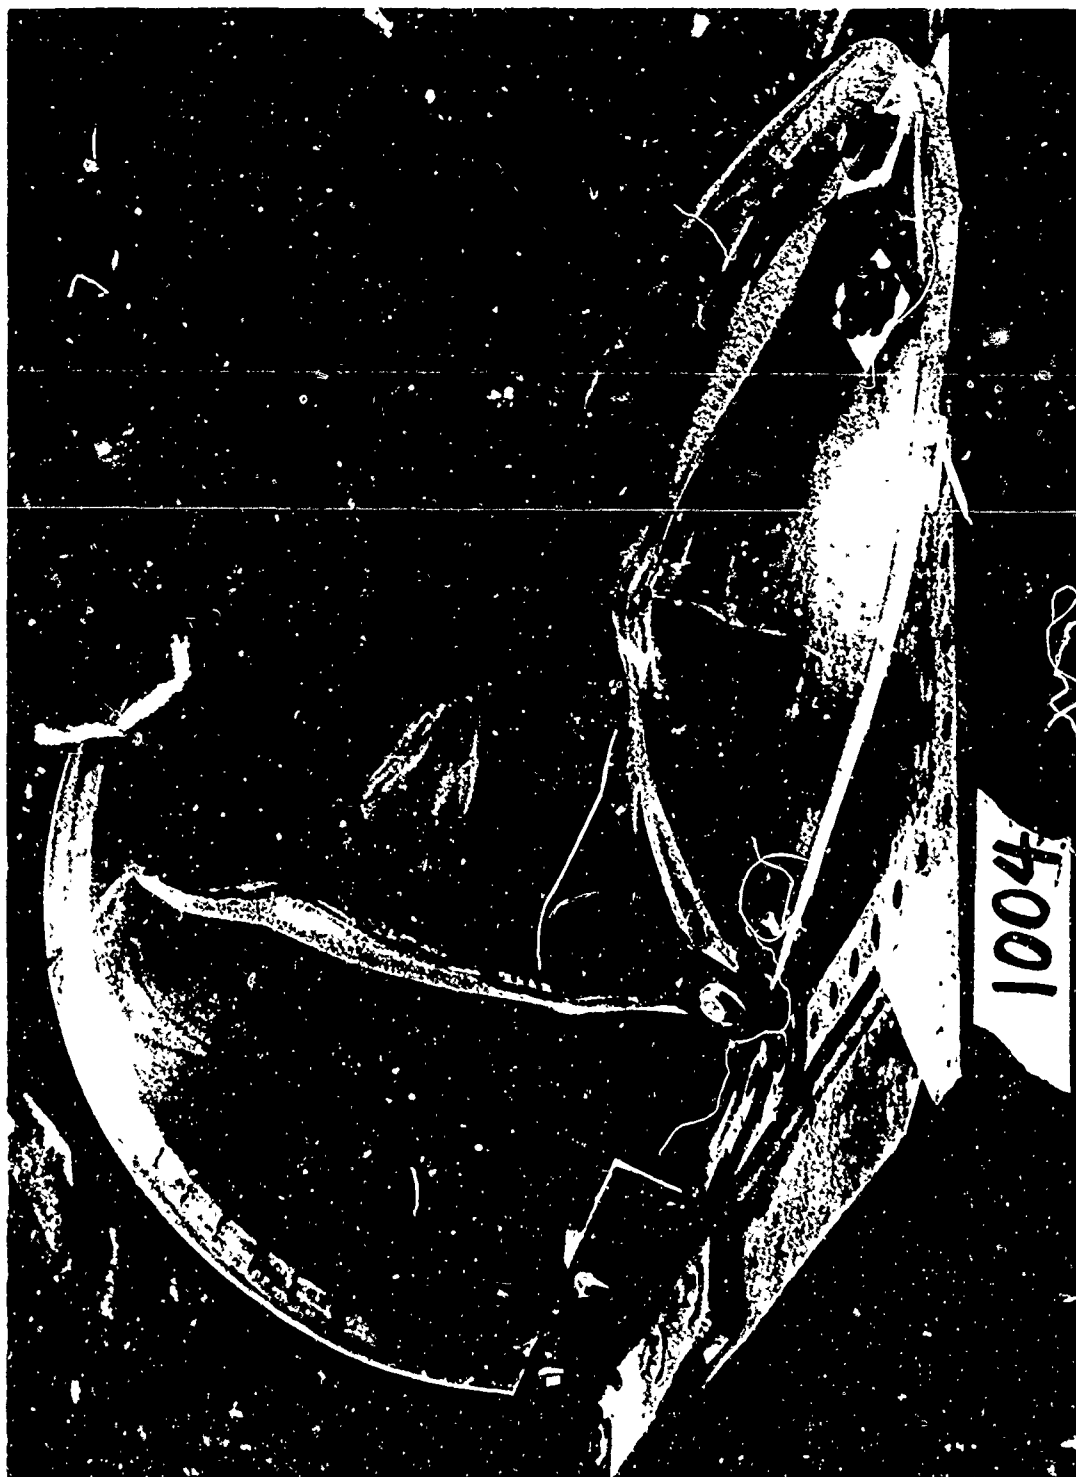
Figure 32. Typical Failure Mode ~ 0.80-In. Stretched Plexiglass Cone-Type Windshield

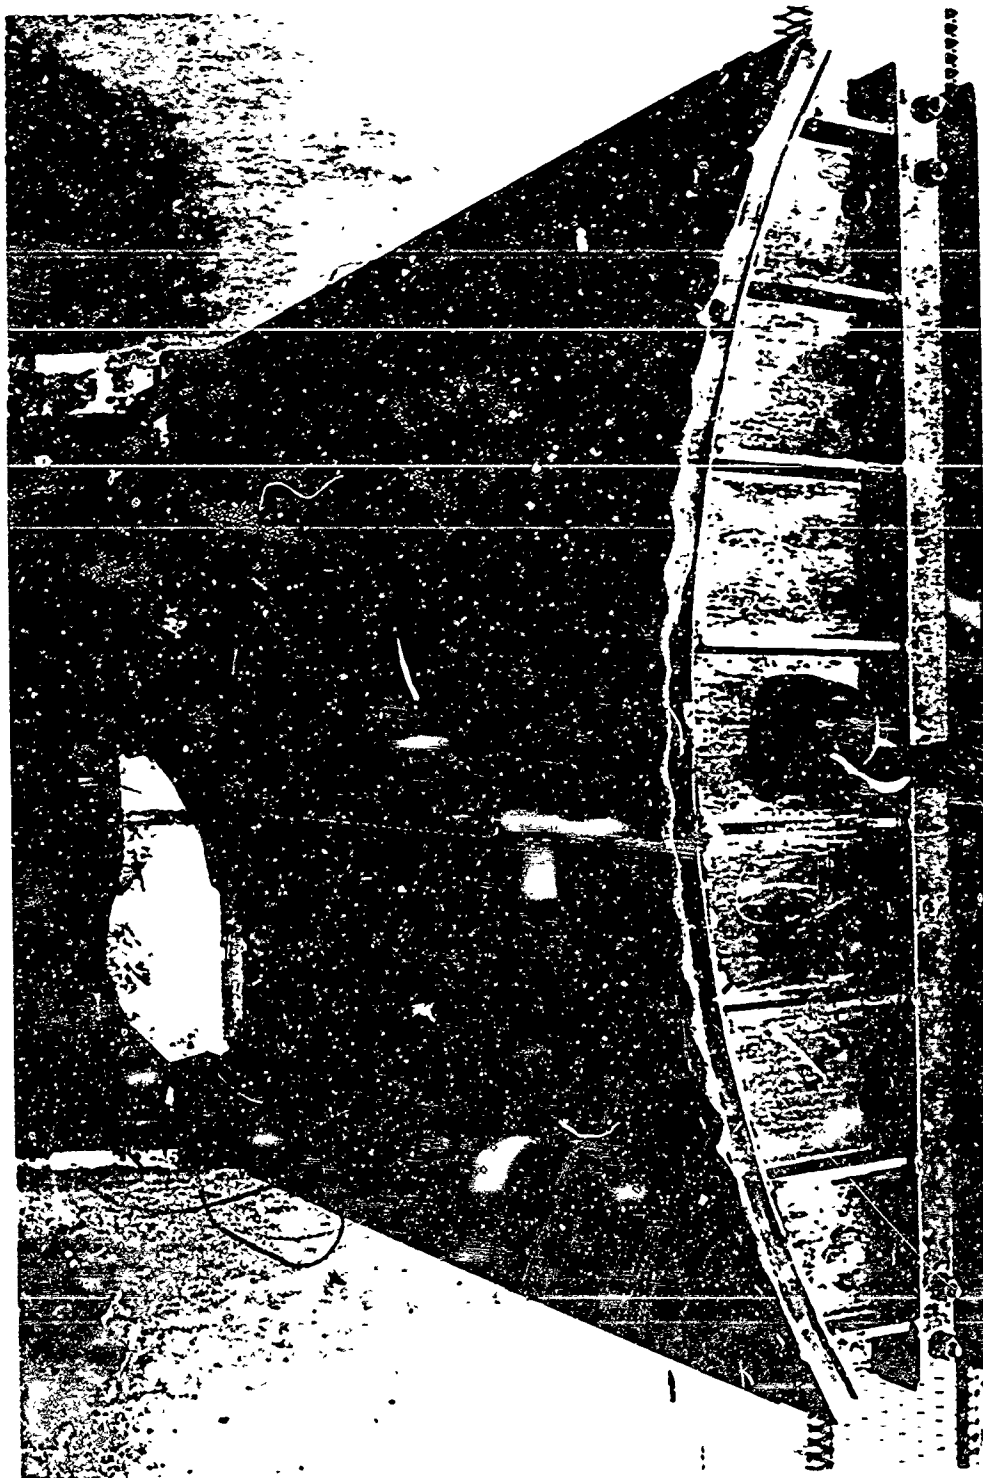
Figure 40. Failure Mode - Large Curved Panel - 1.0-In. x 45.0-In. x 60.0-In. x 40-In. Radius Monolithic Fusion-Bonded Polycarbonate at 30-Deg Bird Impact Angle
